**FATIGUE RESPONSE OF REPAIRED
THICK ALUMINUM PANELS WITH
BONDLINE FLAWS**

THESIS

Presented to the Faculty of the Graduate School of Engineering of the Air Force Institute of
Technology Air University In Partial Fulfillment for the Degree of
Master of Science

Sponsored by both the Fatigue and Fracture Group, Air Vehicle's Directorate (AFRL/VASE)
and the Mission Support Group, Material's Directorate (AFRL/MLSA)..

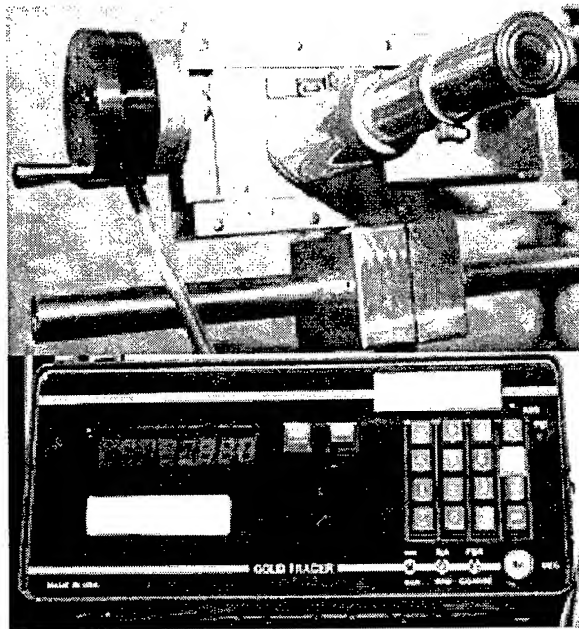
Figure 19. Gaertner Optical Microscope and Digital Readout

The travelling microscope was used on the unpatched side of the specimen to acquire optical crack measurements. A picture of the travelling microscope and digital readout are shown in Figure 19.

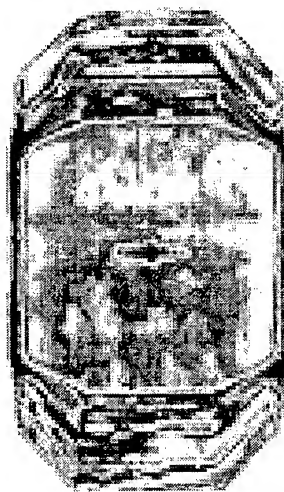
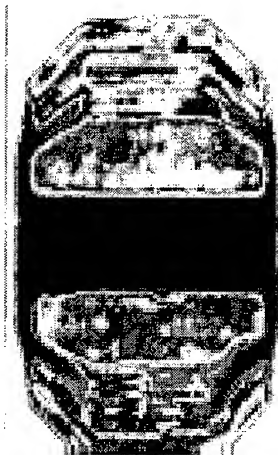
This appendix contains select C-scan images of specimens detailing disbond size as a function of crack length.. A representative of each disbond configuration is presented. Three images from each disbond configuration are included. The first image shows debond size and location at $2a = 25.4mm$, the second at $2a = 63.5mm$ and the third at $2a = 101.6mm$.

Figure 66. C-scan Fully Bonded Patch (FBP) $2a=25.4\text{mm}$

Figure 67. C-scan Fully Bonded Patch (FBP) $2a=63.5\text{mm}$

Figure 68. C-scan Fully Bonded Patch (FBP) $2a=101.6\text{mm}$

Figure 69. C-scan 20% Full Width Disbond (FWD) $2a=25.4\text{mm}$

Figure 70. C-scan 20% Full Width Disbond (FWD) $2a=63.5\text{mm}$

Figure 71. C-scan 20% Full Width Disbond (FWD) $2a=101.6\text{mm}$

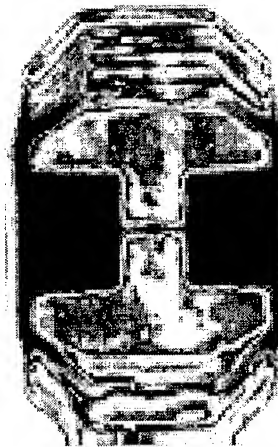
Figure 73. C-scan Crack Tip Disbond (CTD) $2a=63.5\text{mm}$
